Atmospheric Exposure Tests of Nailed Sheet-Metal Building Materials

Building Materials and Structures Report 128

Theodore H. Orem

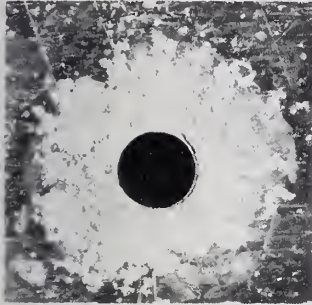
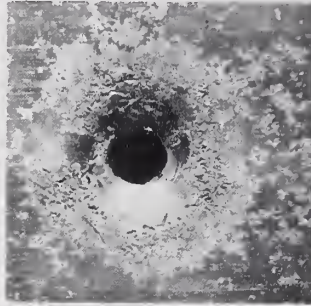
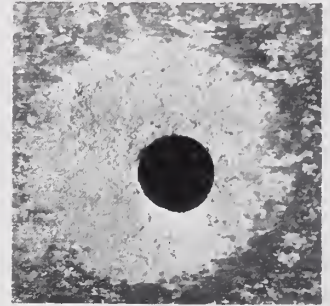
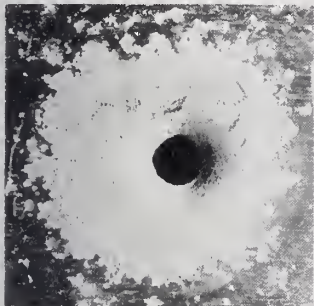
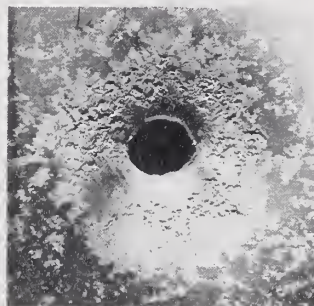
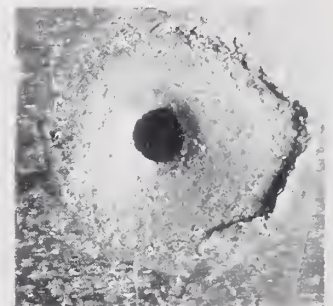
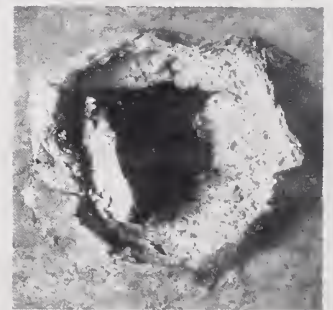
Figures 5 and 6 illustrate the degrees of corrosion from contact with lead washers and of undersurface corrosion, respectively, observed on the aluminum alloys, as indicated in tables 3 and 4.

FIGURE 5. *Lead-washer corrosion ratings for aluminum-base alloys; $\times 2\frac{1}{2}$.*

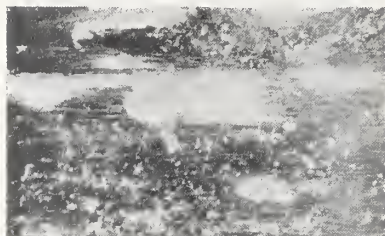
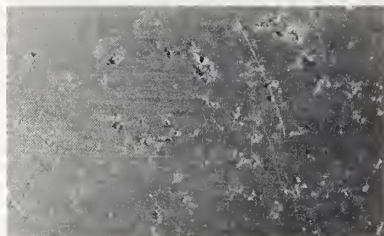
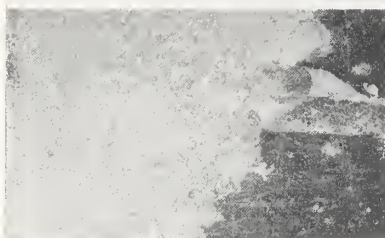
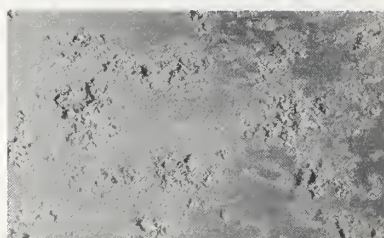
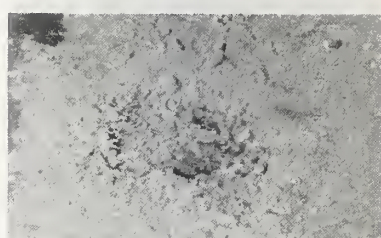
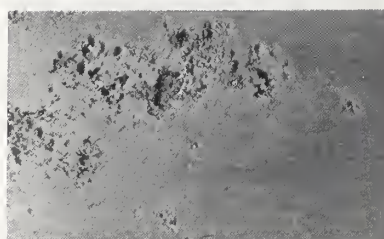
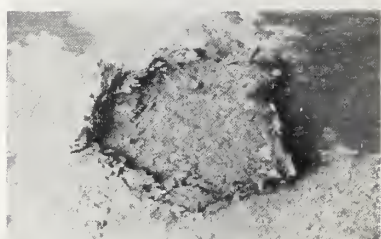
FIGURE 6. *Undersurface-corrosion ratings for aluminum-base alloys.*

Light-colored areas on photographs of materials 5A and 9A are areas where cladding has corroded away. $\times 2\frac{1}{2}$.

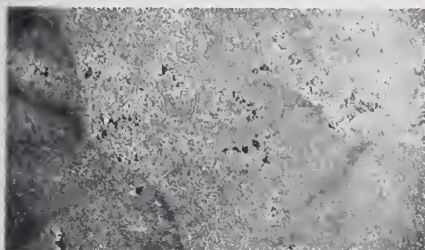
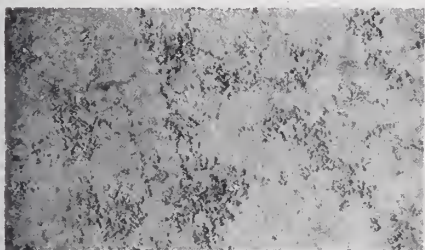
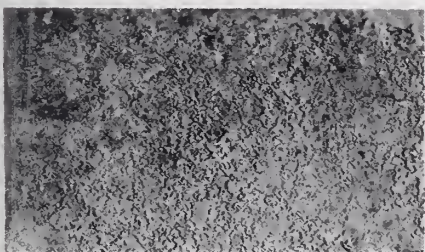
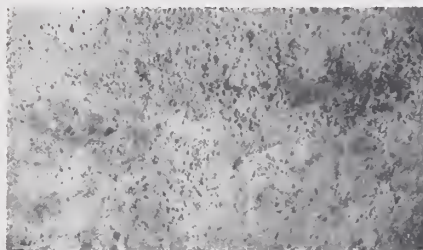
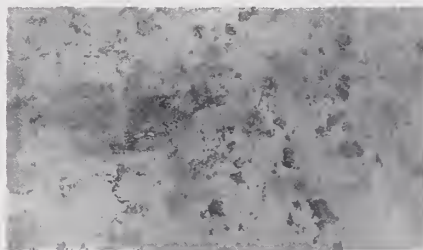
Figure 7 illustrates the various degrees of undersurface corrosion observed on the aluminum-coated and galvanized-steel specimens. Corrosion of the aluminum alloys from contact with dissimilar metal nails used without washers, listed under the column "Galvanic Corrosion" on the inspection charts, may be compared with the pertinent degrees of corrosion caused by contact of the sheets with lead washers, as shown in figure 5.

FIGURE 7. Undersurface-corrosion ratings for aluminum-coated steel and galvanized steel sheets.
Darkened areas are exposed steel in the case of the aluminum-coated steel and an underlying zinc-iron alloy in the case of the galvanized steel. $\times 21\frac{1}{2}$.

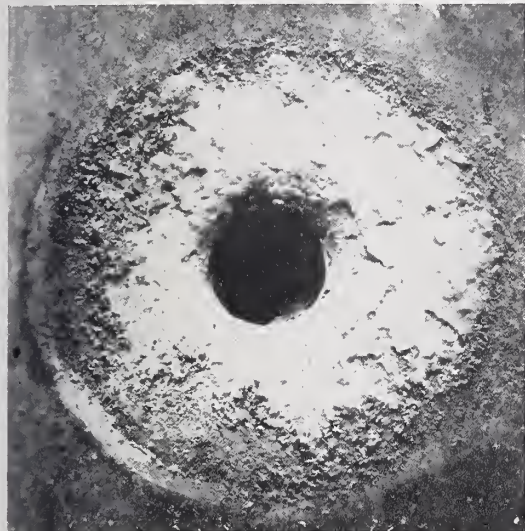
FIGURE 8. *Incrustation of corrosion products between lead washer and aluminum-alloy sheet.*

shown in figure 8, between the sheet and the lead washers after only 3 months of exposure. In the case of materials 1A and 10A this layer of corrosion products was very thin at the end of 3, 6, and 12 months of exposure and considerably heavier after 24 months, at which time moderate pitting occurred in these materials beneath the corrosion products. Moderate pitting similarly was observed on most of the other unclad materials after only 12 months of exposure. The moderate pitting that occurred on all the unclad materials,

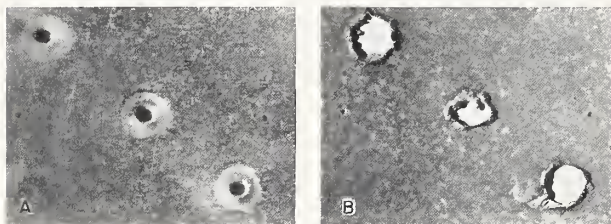
FIGURE 10. Corrosive effect of lead washers on material 9A in a marine atmosphere.

Sheet completely perforated where aluminum nail was used; only cladding corroded where galvanized nail was used. A, Lead washer-galvanized nail; B, lead washer-aluminum nail.

rosion of material 9A due to lead washers where aluminum-alloy and galvanized-steel nails were used. In the latter, only the cladding has corroded away, and there was no significant attack on the core material, probably due to the inhibiting action of the zinc corrosion products of the galvanized steel nail that seeps in between the lead washer and the sheet.

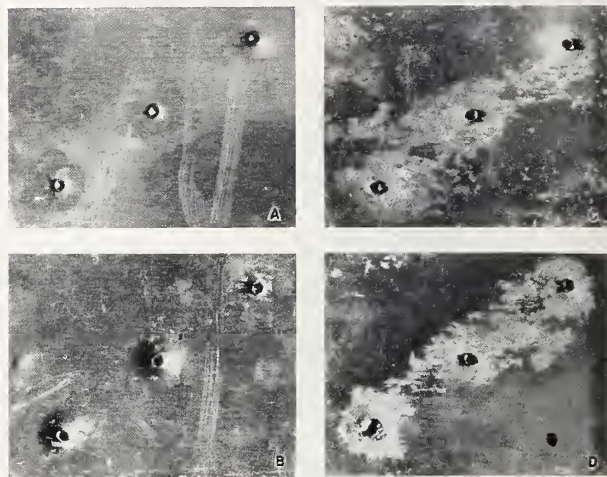
exposure sites when nailed to basswood. Material 9A, which showed unusual corrosion on the undersurface after only 6 months of exposure when nailed to basswood, did not corrode on the undersurface after 6 months when nailed to yellow pine, as illustrated in figure 11. Further evidence that

FIGURE 11. Effect of 6-month contact of material 9A with basswood and yellow pine, respectively.

Note abnormal corrosion of cladding (light areas) where contacted by basswood and absence of corrosion where contacted by yellow pine. A, Yellow pine, NBS site; B, yellow pine, Norfolk site; C, basswood, NBS site; D, basswood, Norfolk site.

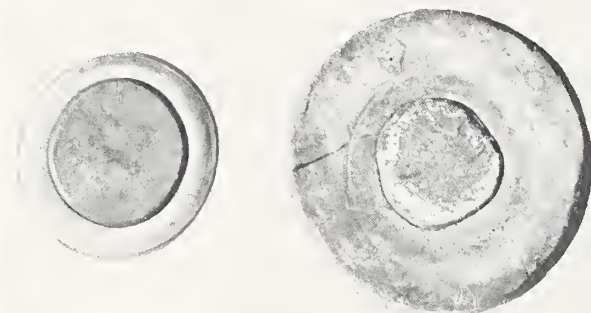
FIGURE 12. *Appearance of cadmium-plated steel nails after use with neoprene and lead sealing washers, respectively.*

Note white corrosion products on nail used with lead washer on right.

the cadmium plate on nails used with lead and neoprene washers after exposure for 6 months. Although the cadmium plate on nails used without washers or with neoprene washers was not noticeably perforated after 24 months of exposure, as indicated by the absence of the yellowish discoloration in their corrosion products, there was evidence of a trend toward deterioration of the plating similar to the initial deterioration of the plating observed on the nails used with the lead washers.

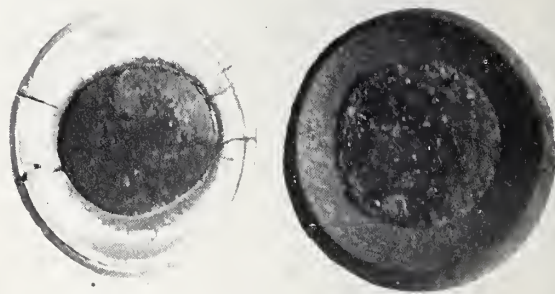
FIGURE 13. *Appearance of neoprene sealing washers after exposure for 1 year at Hampton Roads, Va.*

Note crack-free appearance of carbon-black-filled neoprene washer on right.

trates the difference in the grey molded neoprene washer and the washer cut from carbon-black-filled neoprene sheet after 12 months of exposure. Despite the superiority of the carbon-black-filled neoprene washers, insofar as resistance to hardening and cracking was concerned, they, too, had a tendency to crack at the areas adjacent to the sheet after exposure for 24 months. In this in-

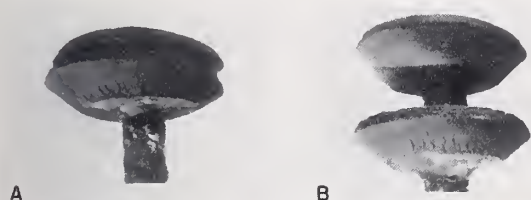
vestigation two carbon-black-filled neoprene washers were used with each nail. The bottom washer, the one in intimate contact with the specimen, was the only one that had cracked (fig. 14). The top washer was free from any cracking (fig. 14).

FIGURE 14. *Cracking of carbon-black-filled neoprene sealing washers after 2-year exposure to the atmosphere.*

A, Washer in normal position. Bottom washer cracked in highly stressed, exposed area. B, Washers in expanded position. Top washer free from cracks in highly stressed, unexposed areas.

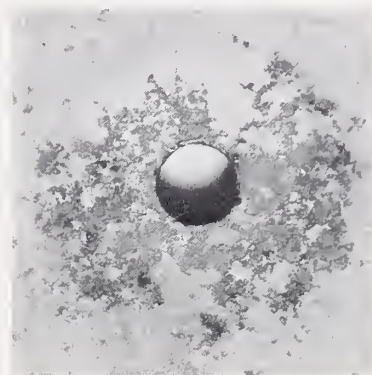
The aluminum-coated steel specimens behaved similarly to the aluminum-alloy specimens, insofar as corrosion from contact with copper and steel nails and lead washers was concerned. All contacts with these materials, except with lead washers on specimens exposed in Washington, caused perforation of the aluminum cladding in less than 24 months, the first perforations occurring on specimens exposed at Norfolk after only 3 months of exposure. Figure 15 is typical of the

FIGURE 15. *Corrosion of aluminum-coated steel due to contact with lead sealing washer in a marine atmosphere.*

Dark area is exposed steel base.

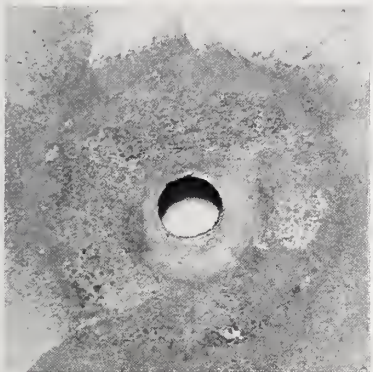
The lead washers caused some corrosion of the galvanized coatings, as shown in figure 16. This corrosion was first noticed after 3 months of exposure at both sites. The rate of corrosion of the coating was very slow, and after 24 months the

coating was only slightly more attacked than at the end of 3 months. There was no significant difference in intensity of corrosion on specimens exposed at Washington and Norfolk. Corrosion of the zinc coating due to contacts with bare steel and copper nails was about equal to that produced by contact with the lead washer, only the outer zinc layer of the coating being attacked.

FIGURE 16. Corrosion of galvanized steel due to contact with a lead sealing washer.

Circular darkened area is exposed zinc-iron alloy layer.

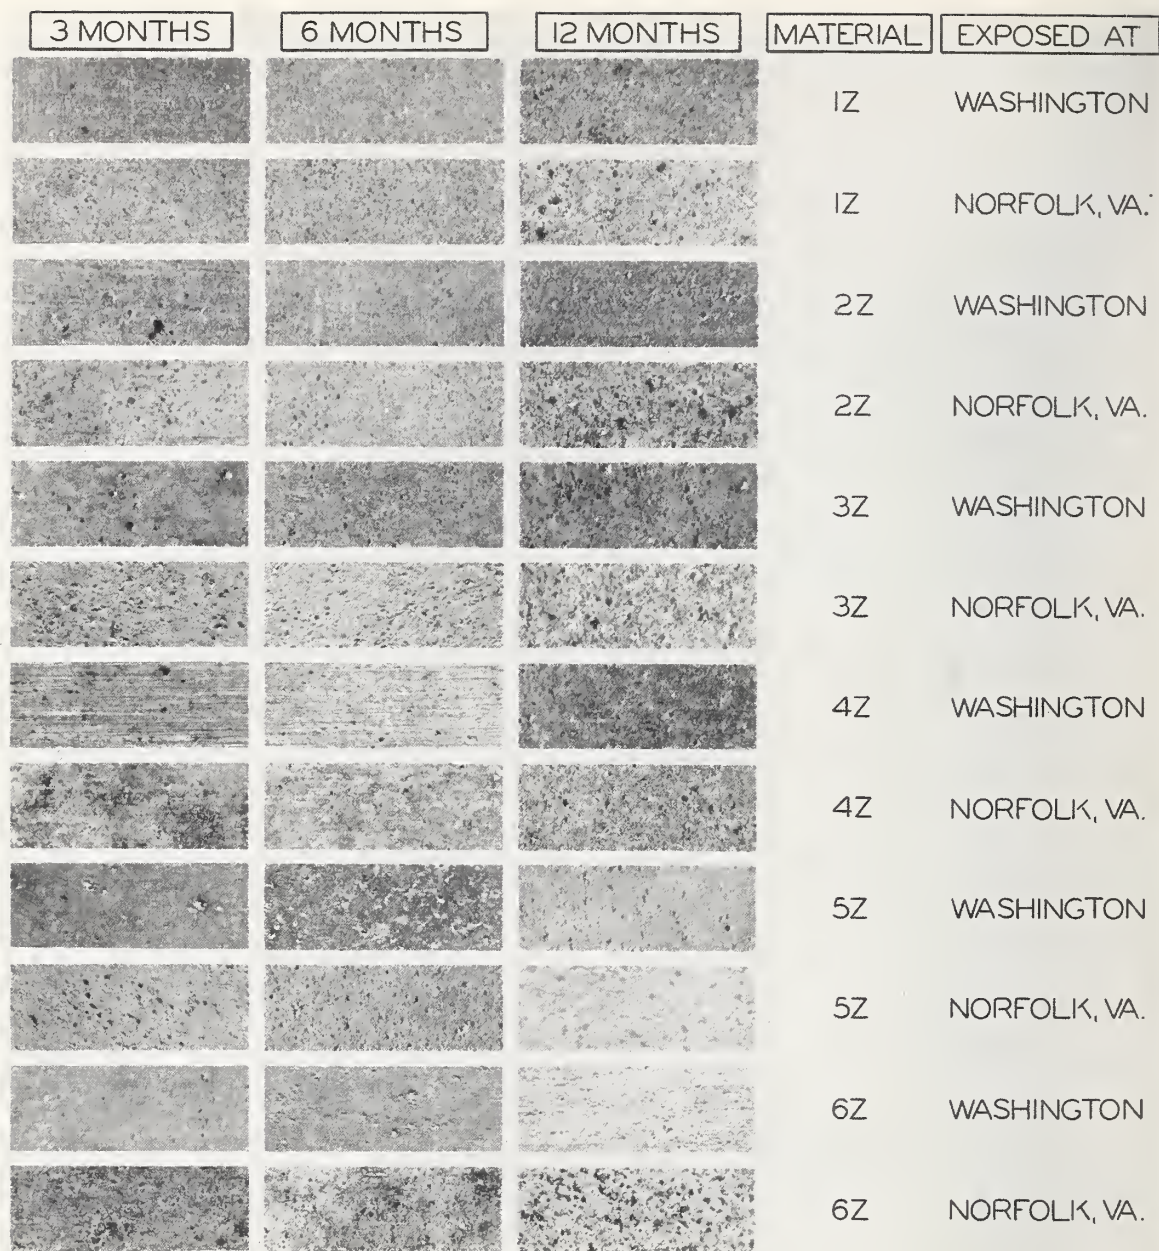
Materials 3Z and 5Z, which were in the cold-rolled condition, were slightly more corroded than hot-rolled materials 4Z and 6Z and also slightly less corrosion resistant than materials 1Z and 2Z, which also are cold-rolled. Since materials 1Z, 2Z, 4Z, and 6Z contained approximately twice as much copper as materials 3Z and 5Z, and since materials 1Z, 2Z, 3Z, and 5Z had been similarly rolled, it appears that the corrosion resistance of the zinc-alloy sheets is influenced more by their copper content than by their rolled condition.

FIGURE 17. Surface appearance of zinc alloys after exposure of 3, 6, and 12 months; $\times 17.6$.
